WHITE PAPER

OpenWRT on the Belkin F5D7230-4

Attaining console access via the native Belkin serial port for OpenWRT development

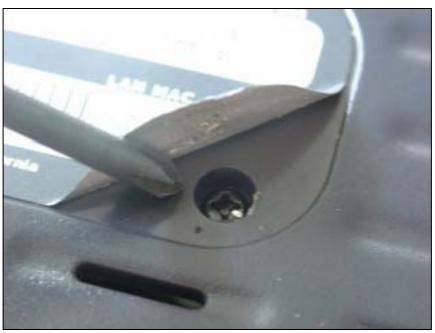
There are two screws in the base of the device that are screwed into the top / lid through the mother-board inside. To remove these screws, lift the two lower corners of the sticker on the base, and use a small phillips-head screwdriver, as shown in this picture;

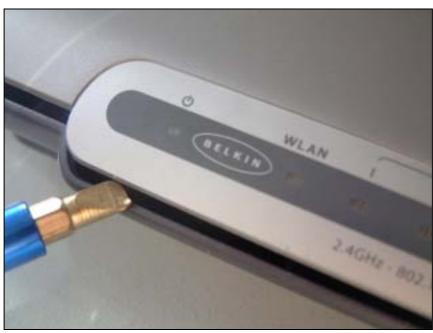
With a flat-head screwdriver, gently wedge in between the top and bottom halves of the case and twist slightly. Repeat this process along the front of the case and then down the sides, as demonstrated in this picture;

Be gentle but firm with this process, as there are eight plastic tabs inside the lid of the device, and they can snap off (there are two on the front and three on either side).

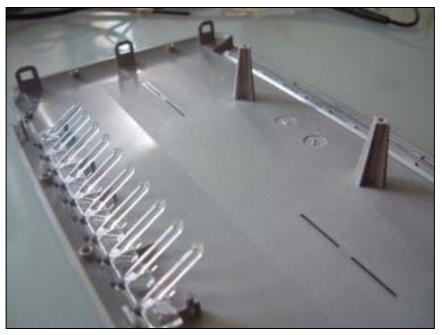
The inside of lid is shown here, with the two screw posts clearly visible. See, also, that the LEDs are not connected to the lid – that clear plastic channels "forward" the light from the micro-LEDs that are surface mounted on the mother-board;

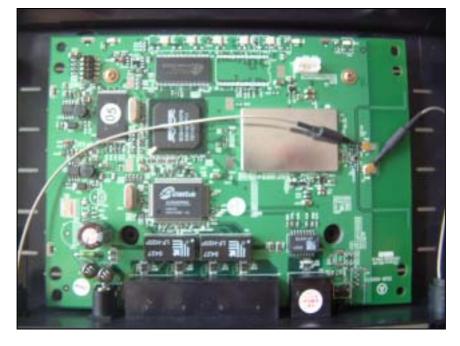
With the casing dismantled, you can now see the inner beauty of Belkin router, model number F5D6230-4;

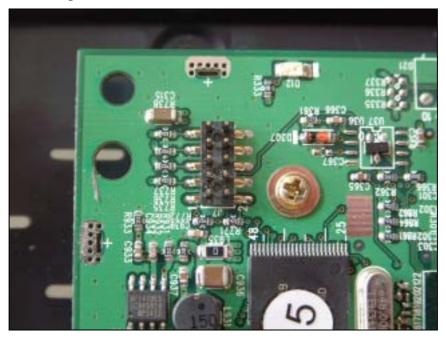
The Linksys' seem to come with at least one large header block – of 10pins – that includes two serial interfaces. The F5D7230-4 also comes with a large, 10pin, header block (labeled J7), pictured here;

Confident that somewhere in either J7 or J2 there was a serial port, testing began on each pin to evaluate them for suitability.

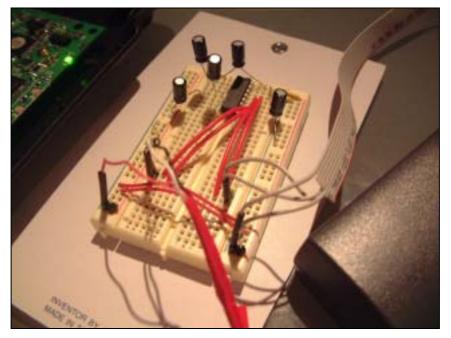
We were confident that we had the found the right pins. So, the converter circuit was rebuilt from scratch, with each component tested for its affect on the overall circuit;

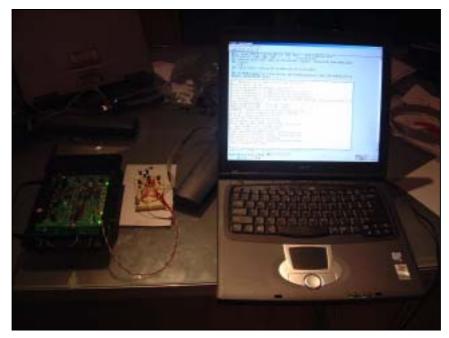
Once this was achieved, a further 10minutes was spent enabling the receive capability on the Belkin (transmit on the PC – console input). An overview of the final workbench layout – with the unseen experimenters giddy from the lack of food, sleep and serial access;

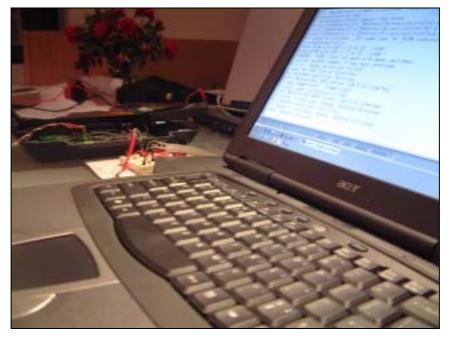
With much love and admiration, even the flowers smiled and sighed at the sign of a successful root serial console – operating at 115,200 bps (8n1);
